DDAS Accident Report

Report date: 13/08/2016	Accident number: 807
Accident time: 10:52	Accident Date: 10/07/2015
Where it occurred: MF: HZTJ99 MF6, Sagirdasht Sub- district, Darvaz, Gorno- Badakhshan Autonomous (GBAO) Region	Country: Tajikistan
Primary cause: Field control inadequacy (?)	Secondary cause: Management/control inadequacy (?)
Class: Excavation accident	Date of main report: 11/08/2015
ID original source:	Name of source: Demining group
Organisation: [Name removed]	Ground condition: dry/dusty; grass/grazing area; soft
Mine/device: PMN AP blast	Date last modified: 13/08/2016
Date record created:	No of documents: 2
No of victims: 2

Task ID: HZTJ99 MF6.

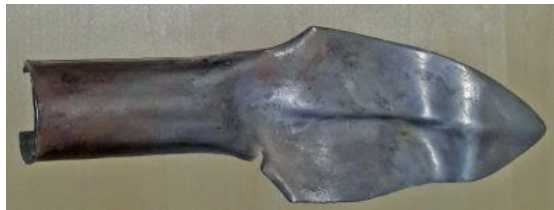
Warped shovel without handle was found 35m away from explosion hole.

[An unclear photograph showing the remains of the “shovel” that was recovered 35 metres away is held on file. The “shovel” is a small trowel made using a single sheet of steel that is curved at one end to form a handle.]

The hand tool provided was made from a single piece of material that prevented separation into component parts but did not meet any of the other recommendations for blast resistance. It did not provide adequate “stand-off” and was so short that the accident record indicates that finger loss in the event of the detonation of a large anti-personnel mine was almost inevitable.

The tool had been subjected to an in-house test by the demining group before being issued. It failed that test dramatically, separating into many parts. However, the test was conducted using a large amount of explosive that was not representative of any mine threat, and this appears to be why the test result was ignored. The use of the tool was stopped by the Programme Manager following the researcher’s investigation. Blast resistant tools are being used pending the design of a locally produced alternative.
