# DDAS Accident Report

<b>Report date:</b> 25/08/2016	<b>Accident number:</b> 812
<b>Accident time:</b> 10:45	<b>Accident Date:</b> 17/05/2016
<b>Where it occurred:</b> Risk Area 12, Tal Al-Rabiea Village, Daquq, Kirkuk Governorate	<b>Country:</b> Iraq
<b>Primary cause:</b> Other (?)	<b>Secondary cause:</b> Management/control inadequacy (?)
<b>Class:</b> Handling accident	<b>Date of main report:</b> Not recorded
<b>ID original source:</b>	<b>Name of source:</b> Iraqi Kurdistan Mine Action Agency
<b>Organisation:</b> FSD	
<b>Mine/device:</b> IED	<b>Ground condition:</b> dry/dusty; hard
<b>Date record created:</b>	<b>Date last modified:</b> 25/08/2016
<b>No of victims:</b> 1	<b>No of documents:</b> 2

## Formal report

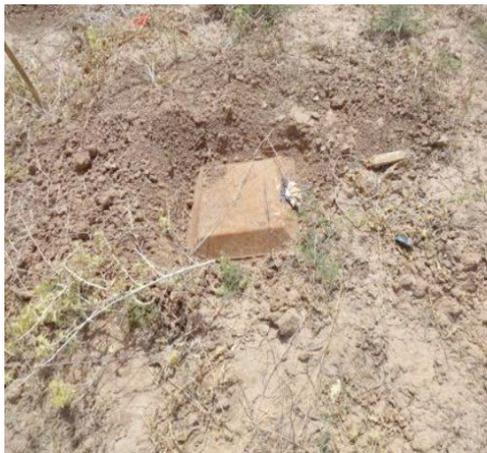
On 17/05/2016 the operation manager of [Demining organization involved] has contacted us by telephone to inform about explosion of an IED in their worksite or the risk (Hazard) area 012 in the village of Tal Al-Rabiea /Daquq /Kirkuk and after the call, the in-charge person of Quality Assurance: [Name removed] and his assistant: [Name removed] we have moved toward the location in order to collect necessary information and taking the photos of the place of the incident. According to the information gained by the board it was found that the affected person: [the Victim] has intended to render some IEDs safe by using a method to defuse and drag of 8 IEDs. The affected person has used the detector VMH3CS to make more sure about detecting the IEDs. He has also made risk assessment for his work before commencement. He also asked all the personnel to get away from the place by a safety distance. He has rendered the first IED and handled the defuse to the team leader and then he asked again the personnel to get away from the place by an appropriate safety distance. At the time he was working on rendering the second safe (IED), the explosion took place.

The first IED was defused by [the Victim].
