DDAS Accident Report

Report date: 08/04/2019	Accident number: 814
Accident time: 11:40	Accident Date: 25/09/2017
Where it occurred: Sarichashma MF-10, Shamsiddin Shohin district, TAB, Khatlon Province	Country: Tajikistan
Primary cause: Victim inattention (?)	Secondary cause: Field control inadequacy (?)
Class: Excavation accident	Date of main report: 29/09/2017
ID original source: MAR #1/17	Name of source: [Name removed]
Organisation: [Name removed]	Ground condition: hard; metal fragments; rocks/stones; steep slope
Mine/device: PFM-1 AP blast	Date last modified: 08/04/2019
Date record created:	No of documents: 2
No of victims: 1

Accident report

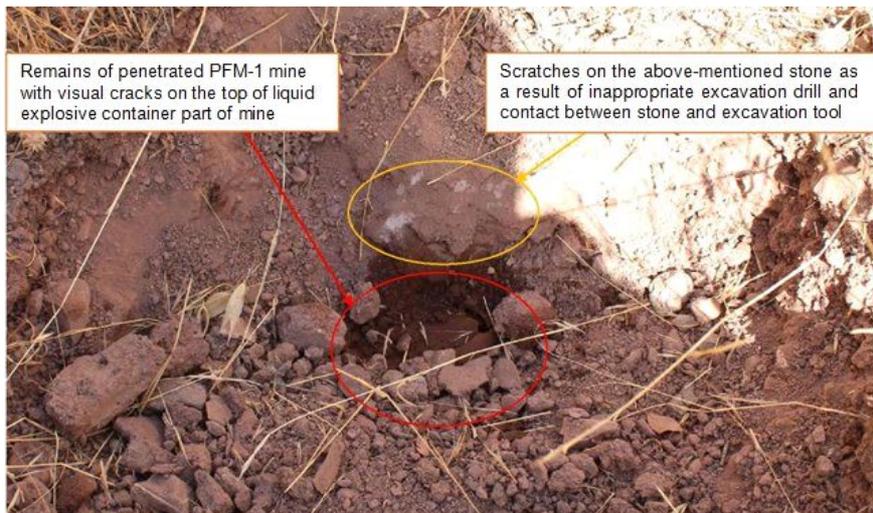
As detonation did not occur, there is no crater or other similar remaining signs of an accident. Remains of the PFM-1 mine are still at the accident location and approximately 30 cm from the base stick.

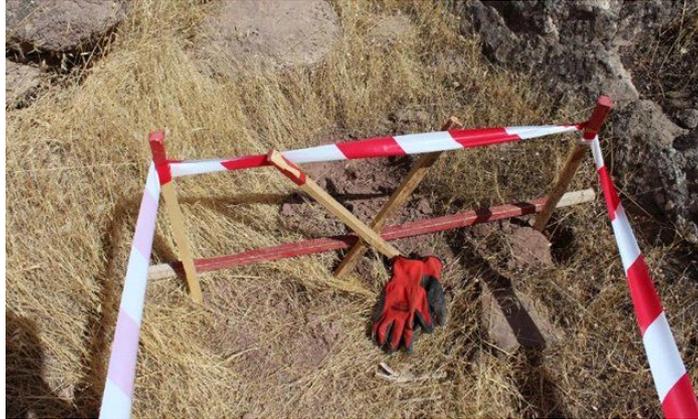
An additional fragment/ remnant of PFM-1 mine was found during the investigation above the penetrated mine, leading the board to believe that there was a fragment/ remnant of one PFM-1 found before the PFM-1 mine which caused the accident. It is assumed that the deminer may have believed that there is no risk as she had found just a fragment and therefore excavated less cautiously.

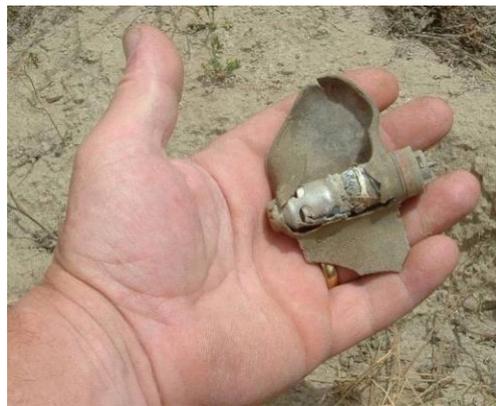
The accident raises questions over why a live PFM-1 did not detonate when pressure was applied to its flexible body. The PFM-1 mines were deployed from a helicopter, so were not intentionally buried. The weather (snow and rain) had washed them to a level ridge where they had subsequently become buried. The potential for the mines to have been gathered in close proximity or on top of each other was obvious. However, most PFM-1 mines that have been exposed to sunlight (UV) for a long period in Tajikistan have split and their volatile liquid explosive has been dissipated as shown below.

The casing of the mine involved in this accident was intact but may have been hardened by the sun before it became buried, so making it easier to accidentally break open without the case flexing and pushing the liquid explosive into the fuze and making it detonate.
