DDAS Accident Report

| Where it occurred: Task # 1182, Lataband Village, Talugan District, Takhar Province | Country: Afghanistan |
| Class: Excavation accident | Date of main report: 17/07/2006 |
| Mine/device: PMN-2 AP blast | Ground condition: dry/dusty grass/grazing area hard |

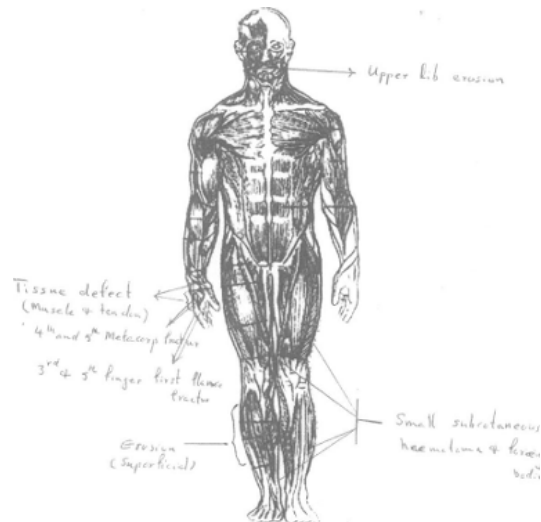
One deep wide and serious injury on his right hand with tissue defect and multiple fractures

Right Ulna bone distal portion fracture.

Right hand 4th & 5th Metacarp bone fracture.

Both side of right hand has wide tissue, muscle and tendon defect.

His general condition is good but according to the German surgeon specialist the prognosis of right hand injury is very bad, because of very bad multiple fractures and tissue defect. If he get a good chance with current treatment, he wouldn't able to use his right hand as a normal hand. The chance of complication like necrosis, gangrene, osteomyelitis and amputation is present.
