# DDAS Accident Report

AMAC HERAT INVESTIGATION ON EXPLOSIVE ORDNANCE ACCIDENT AT SHAYDAEE AMMUNITION COLLECTION POINT, HEART, ON 5TH SEPTEMBER 2006

EXPLOSIVE ORDNANCE ACCIDENT AT SHAYDAEE AMMUNITION COLLECTION POINT

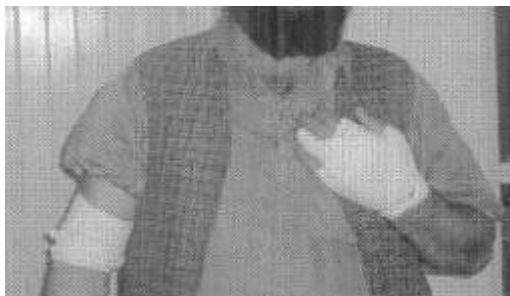
“Received a deep cut to the inside joint of his right arm. Artery was not cut. Bleeding was successfully stopped at Sheydayee.

“Fragmentation wound to back of right hand. X Ray indicates that fragmentation is still embedded.”
