# DDAS Accident Report

<b>Report date:</b> 25/01/2008	<b>Accident number:</b> 509
<b>Accident time:</b> 09:10	<b>Accident Date:</b> 18/01/2007
<b>Where it occurred:</b> MF # AF/3208108364/MF01 1, Dwa-Mandy Village, Nadersh-Kot District, Khost Province	<b>Country:</b> Afghanistan
<b>Primary cause:</b> Field control inadequacy (?)	<b>Secondary cause:</b> Victim inattention (?)
<b>Class:</b> Detection accident	<b>Date of main report:</b> 24/01/2007
<b>ID original source:</b> OPS/2/2/21-014-07	<b>Name of source:</b> UNMACA
<b>Organisation:</b> [Name removed]	
<b>Mine/device:</b> PMN AP blast	<b>Ground condition:</b> dry/dusty rocks/stones
<b>Date record created:</b>	<b>Date last modified:</b> 25/01/2008
<b>No of victims:</b> 1	<b>No of documents:</b> 2

Subject: Demining Accident Investigation Report of [National demining agency] MCT#1

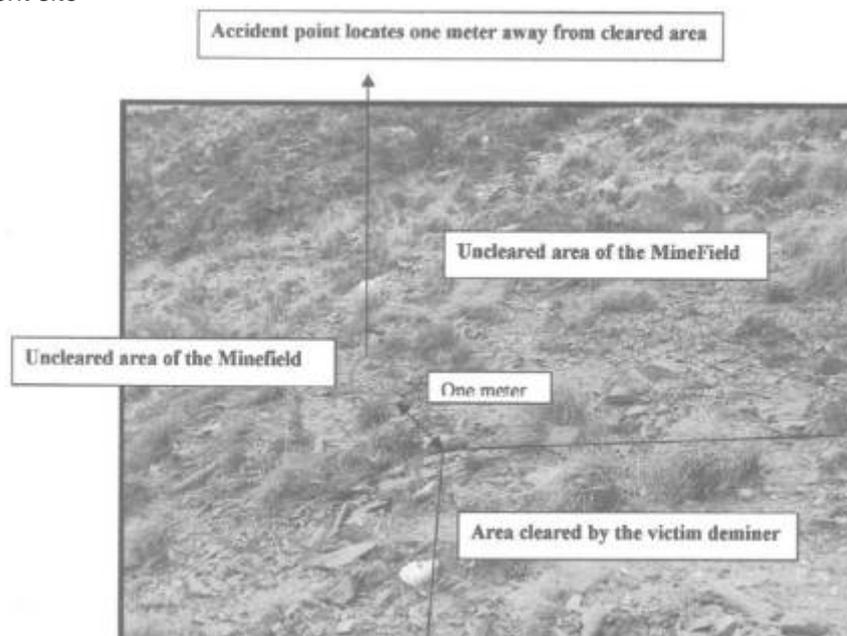
Device was detonated in area where it was difficult to be clear from the right to left, due to sloppy [sloping] condition.

The accident site

**Description of the incident/accident:** The deminer was tasked to clear across the slope before clearing up the slope and it appears that he has carelessly moved into an unclear area before physically clearing it and has stepped on a PMN Mine.

3. That Section Commanders ensure that their deminers fully understand how to perform clearance before moving into the hazard area and if they are unsure then they should ask for clarification immediately.
