# DDAS Accident Report

## Demining Investigation Report

Date of incident/accident: 22 December 2005

Location: Former Border Regiment-5, Dopushta, Injil District, Herat Province

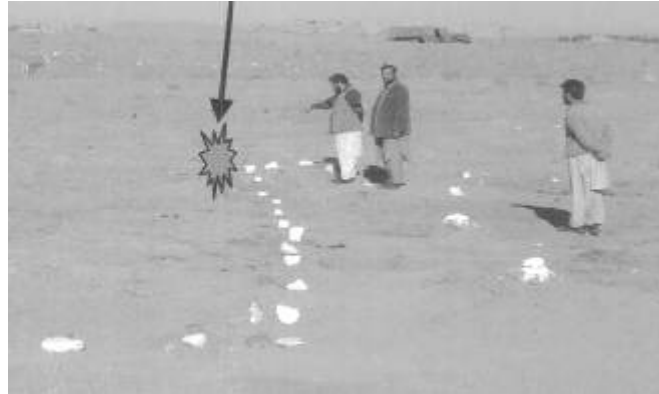
It is unfortunate that the investigators conducted their investigation without wearing PPE. This is not uncommon, but does set a bad example to the deminers. Their inclusion of a photograph showing them at the accident site implies that it is normal for them to enter a mined area without PPE.
