DDAS Accident Report

BOARD OF INQUIRY (BOI) REPORT 003/2007

on [International demining company] INTERNATIONAL LIMITED DEMINING ACCIDENT that occurred on the 05th March 2007 in which a [International demining company] Deminer was injured

Ref No. 03/2007

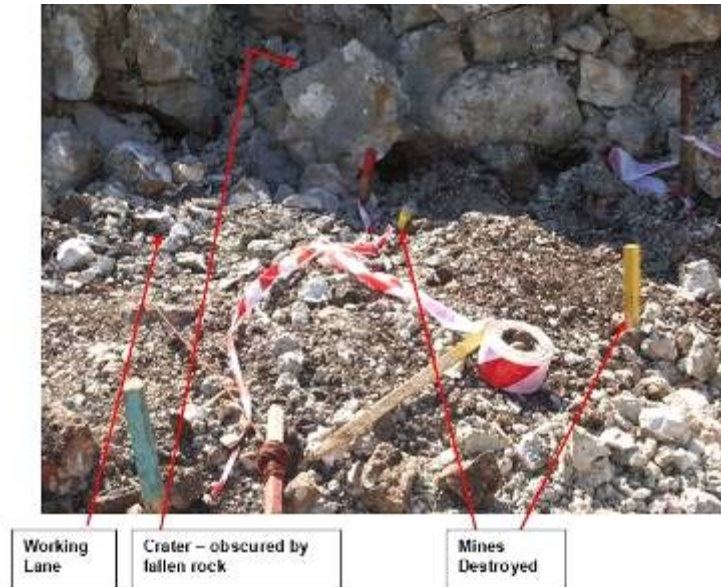
MF 356 is a challenging mine clearance task with increased hazards to working Deminers due to the steep rocky terrain and mine types (No4A incorporating the No9 fuze). Extreme vigilance, good disciplined and close supervision is therefore essential.

Based on the evidence gathered at the accident site, medical reports and interviews conducted by the MACC SL BOI team during the course of the investigation; it is of the opinion of the BOI team that the mine was positioned in the uncleared area to the front of the demining lane. It had been buried in the ground or covered by rocks and had been initiated as a result of direct pressure from one or more rocks falling from the rocky slope above.

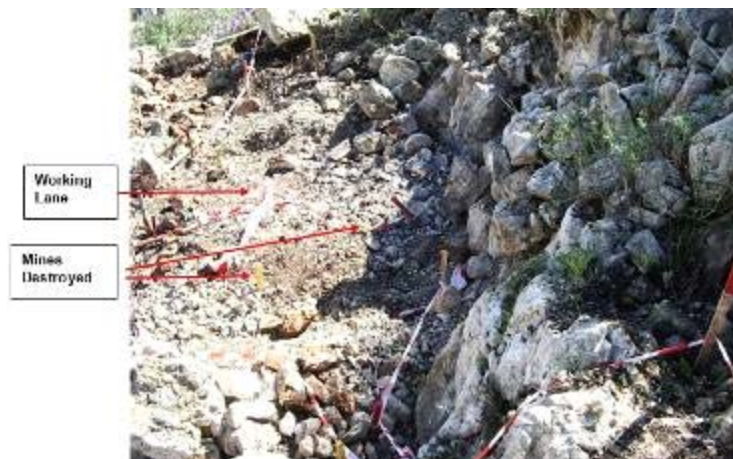
On 05 March 2007 at 0953 hrs, [the Victim], a [International demining company] Deminer was involved in a Demining Accident at [International demining company] Task MF 356 (Sowaida position). [The Victim] was removing a rock from the front of his lane during the course of the manual mine clearance operations when an explosion occurred, resulting in injuries to his left arm, hand and head.
