DDAS Accident Report

Report date: 08/04/2019	Accident number: 814
Accident time: 11:40	Accident Date: 25/09/2017
Where it occurred: Sarichashma MF-10, Shamsiddin Shohin district, TAB, Khatlon Province	Country: Tajikistan
Primary cause: Victim inattention (?)	Secondary cause: Field control inadequacy (?)
Class: Excavation accident	Date of main report: 29/09/2017
ID original source: MAR #1/17	Name of source: [Name removed]
Organisation: [Name removed]	Ground condition: hard; metal fragments; rocks/stones; steep slope
Mine/device: PFM-1 AP blast	Date last modified: 08/04/2019
Date record created:	No of documents: 2
No of victims: 1

Accident report

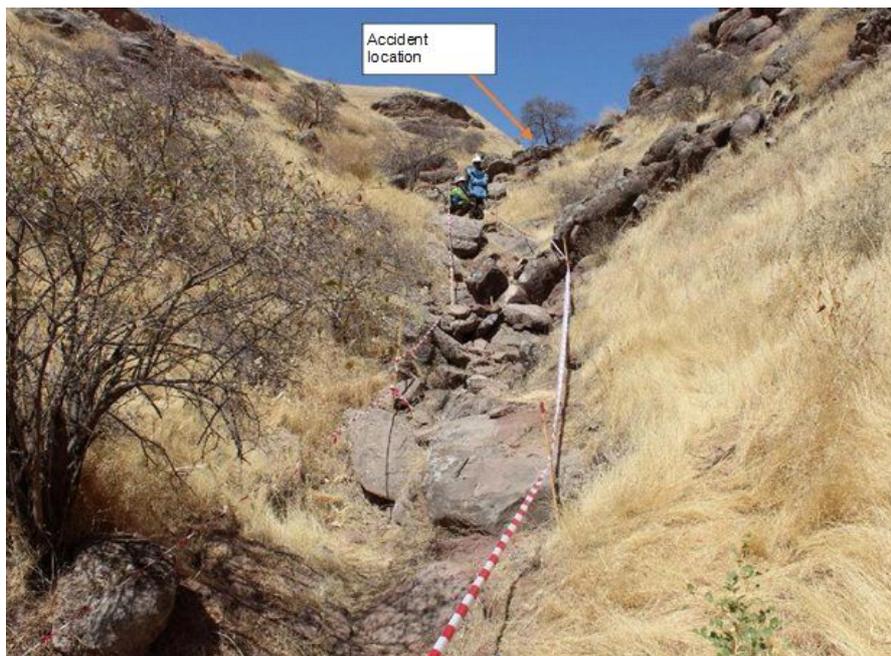
The accident occurred in one of the remote Mine Field (MF) tasks (HZTJ-335-MM10) located in TAB region of Tajikistan, Shamsiddin Shohin district: 30 km from nearest hospital, 60 min of driving by narrow and bad condition restricted border zone road, and was caused due to hand excavation tool (demining trowel) penetration into the liquid explosive container of an AP blast mine type PFM-1. Penetration, fortunately, did not provoke any detonation, but resulted in rupturing the plastic mine casing and spraying of the liquid explosive charge contents into the eyes, mouth and facial area of the deminer operating the demining tool.
